Manhole Inspection Summary

Manhole # S17C1_022MH

Insp Date: **5/15/08 10:28 AM**

Location Address: **1908 letitia av**

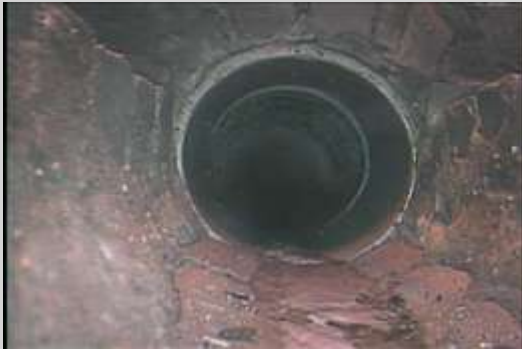
12 O'Clock Outflow

8 in. Circular Gravity Sewer
Pipe Out @ 12 O'Clock

Pipe Height: **8.4** (in.) Rod and Bar (Angled)
Pipe Material: **Clay** ☐ Pipe Lined
Invert Depth: **8.66** (ft.) Flow Characteristics: **Slow**
Deposits: ☒ None ☐ Mud ☐ Sludge ☐ Debris ☐ Grease
Silt Depth: **0** (in.) Deposits Extent:
Infiltration: **None** Pipe Seal Cond: **Sound**
